JOHNSON COUNTY COURTHOUSE ROOF AND TOWER REPAIRS

SHPO Milestone #2

October 2017

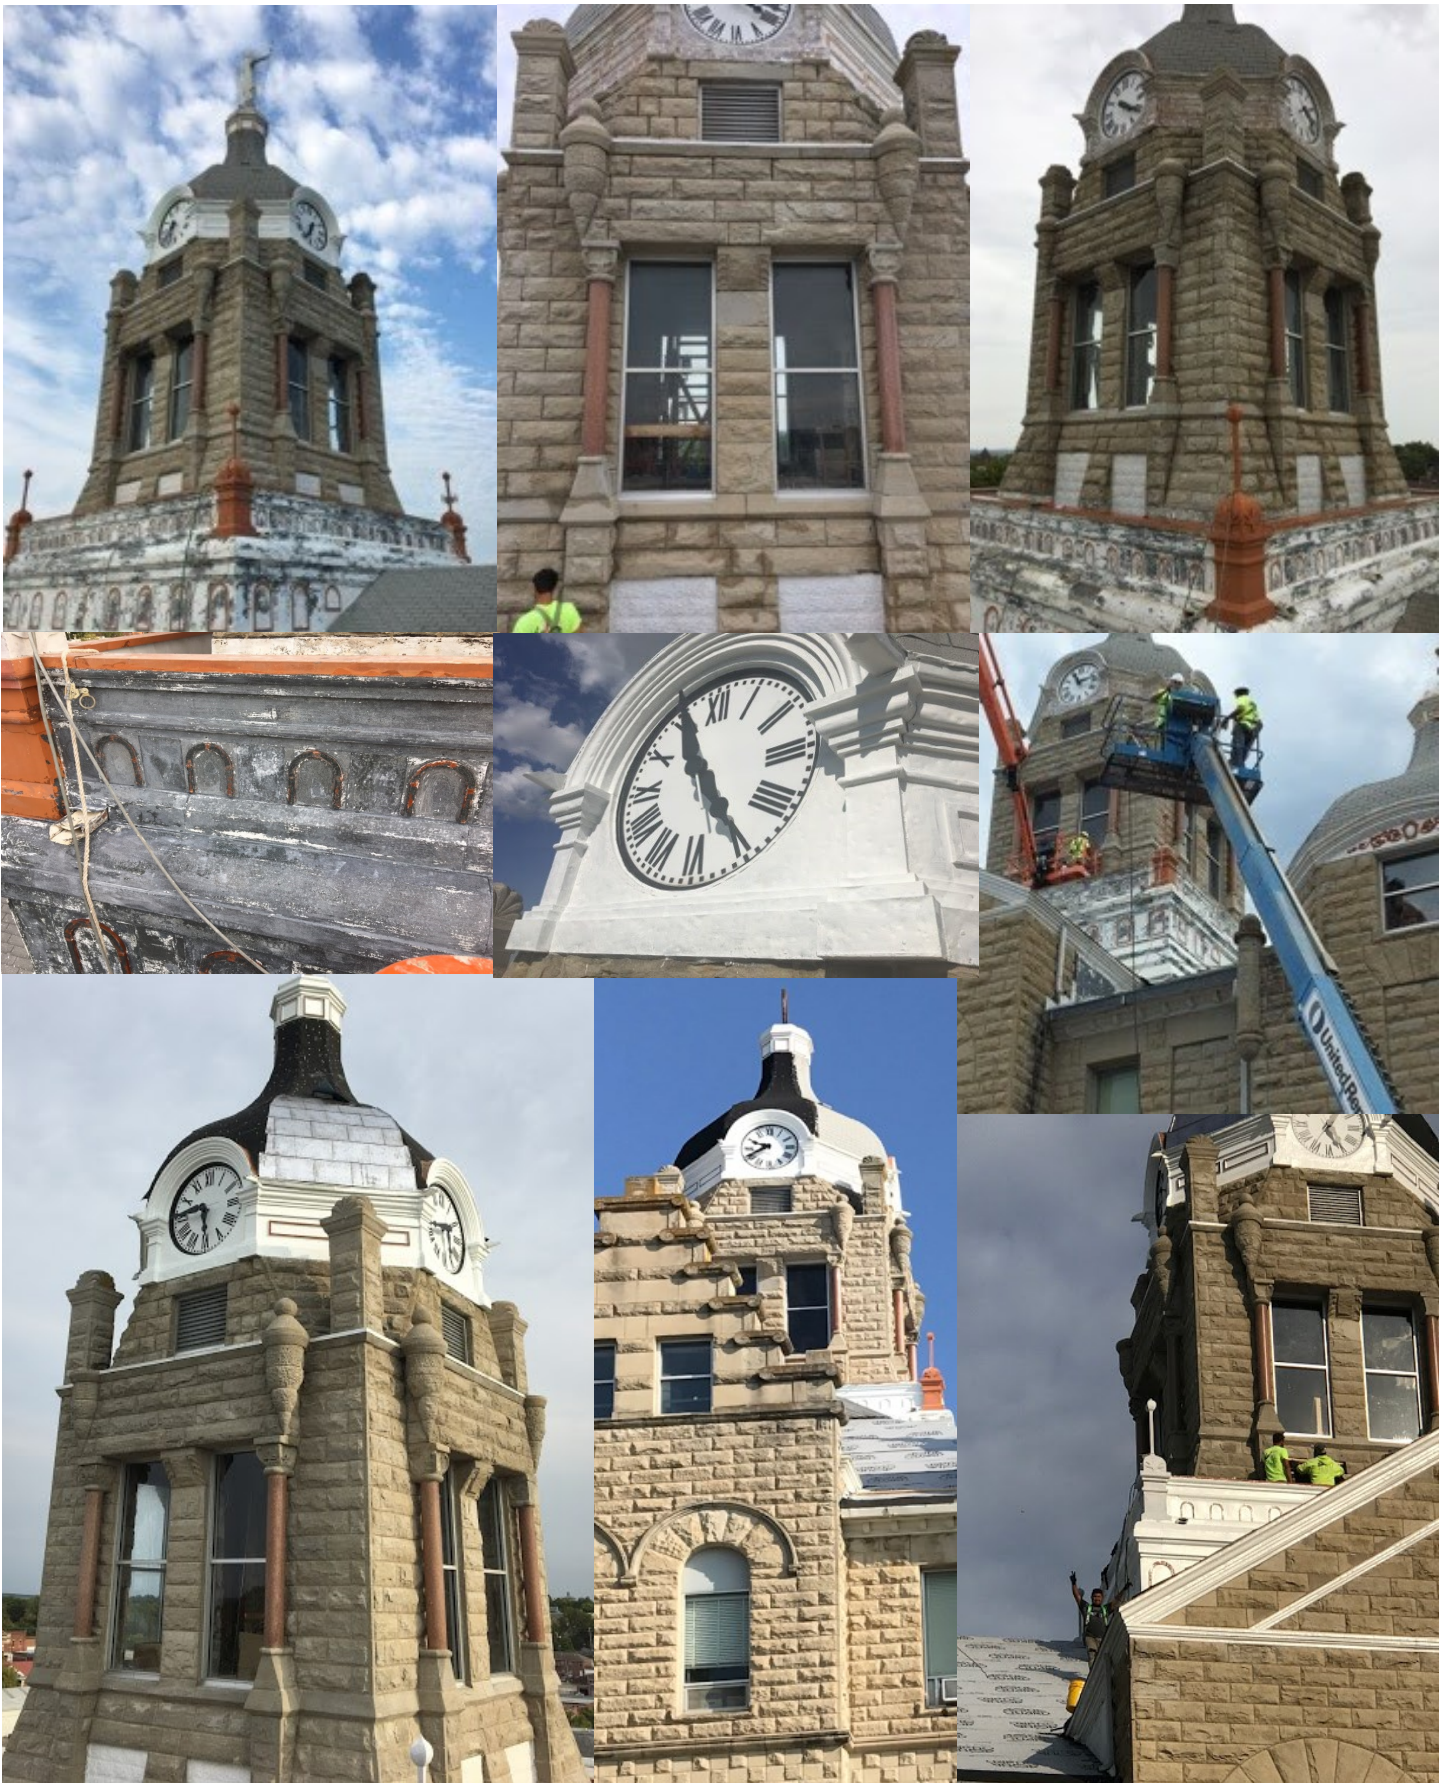
Tower: Clocks being primed and painted. Partial roof torn off and papered in. Four sides of lead coated copper flat lock pans started.

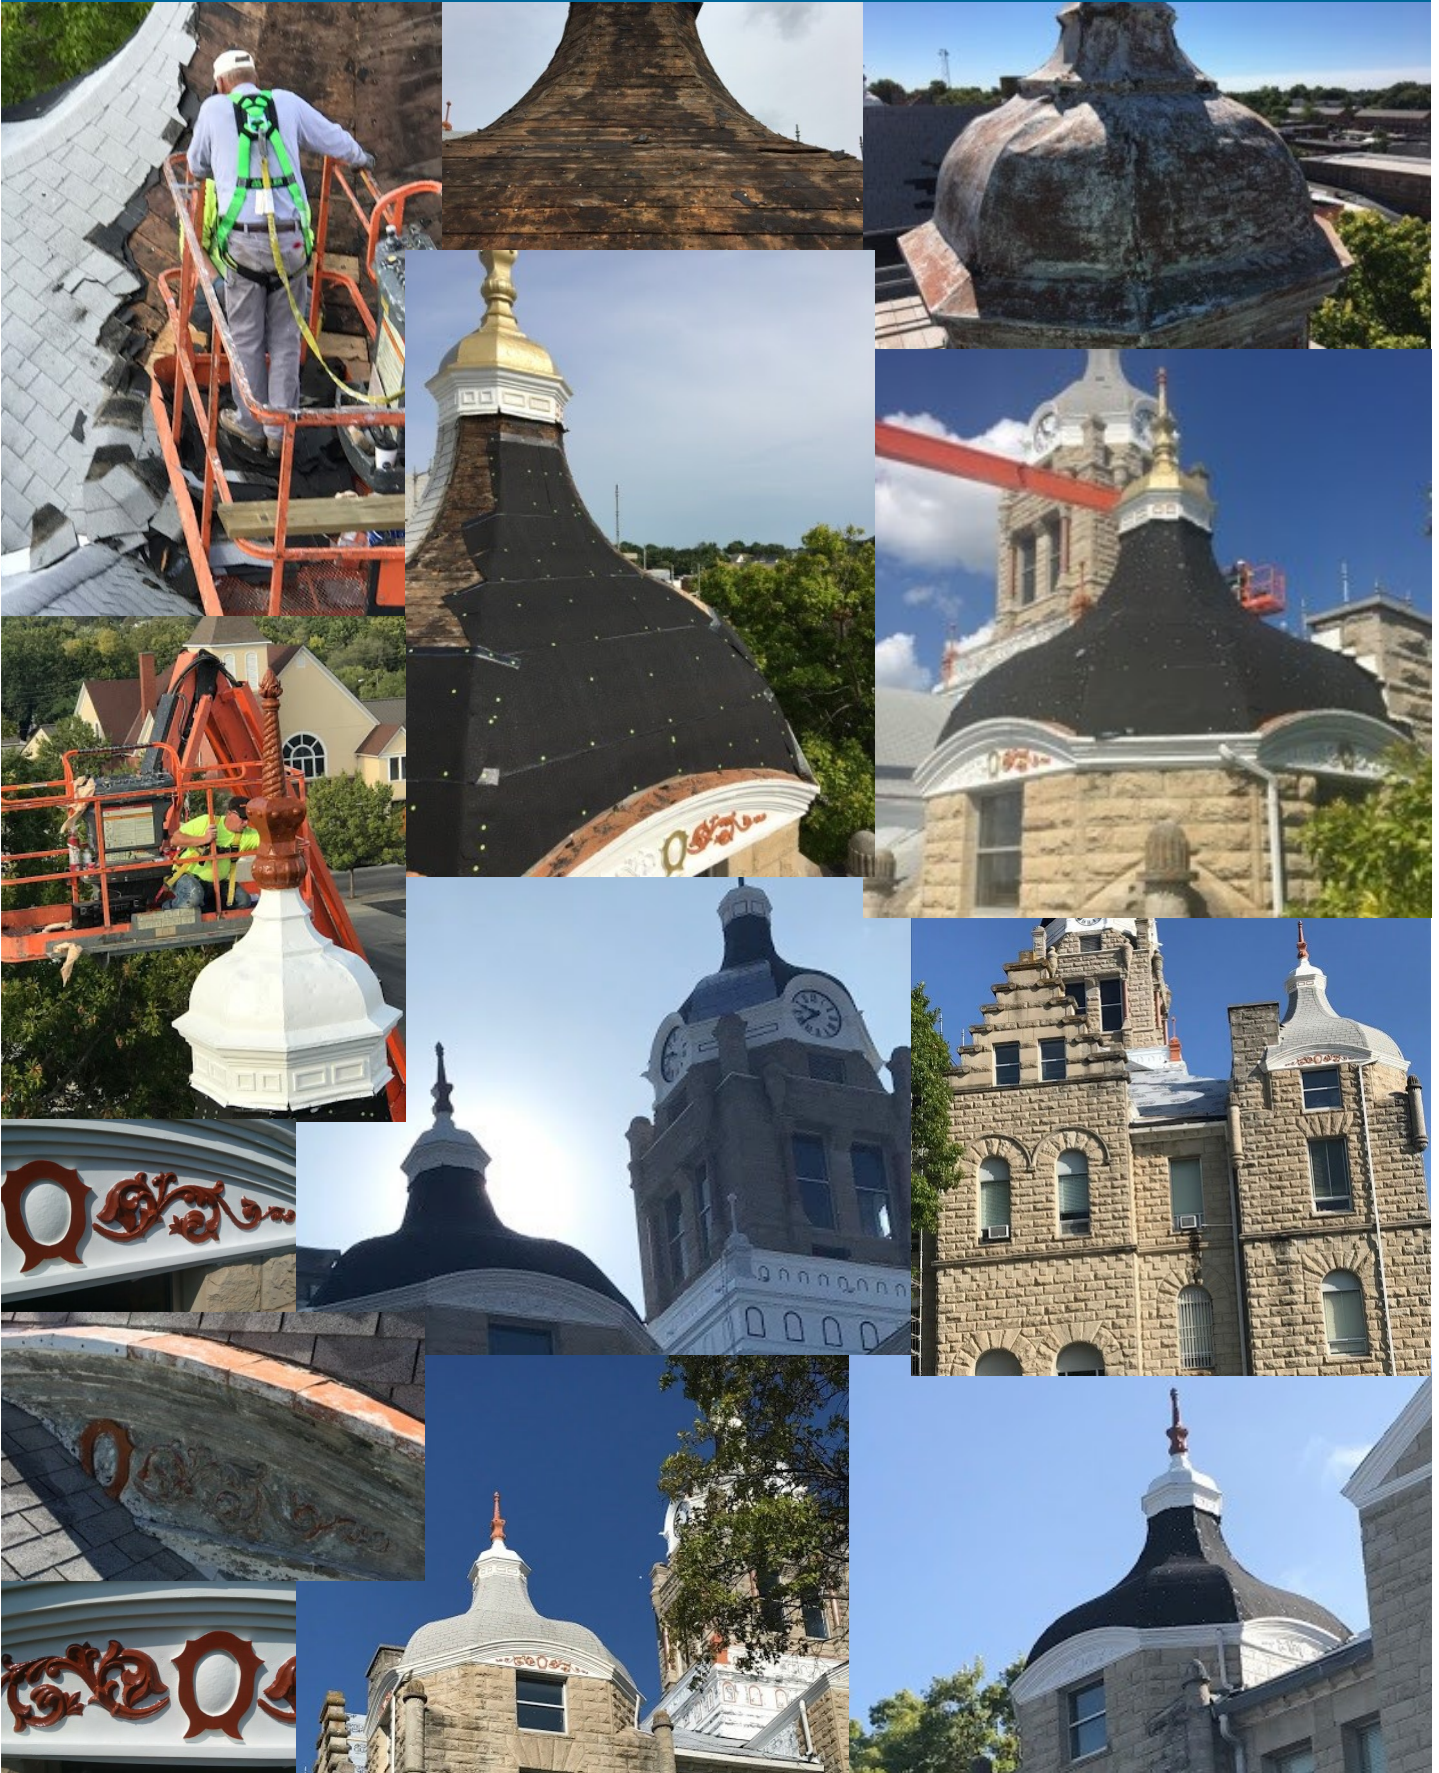
Ogee Domes: SW & NW paint preparation, primed, shingles removed, papered, 2 sides LCC; NE paint preparation shingles removed and papered.

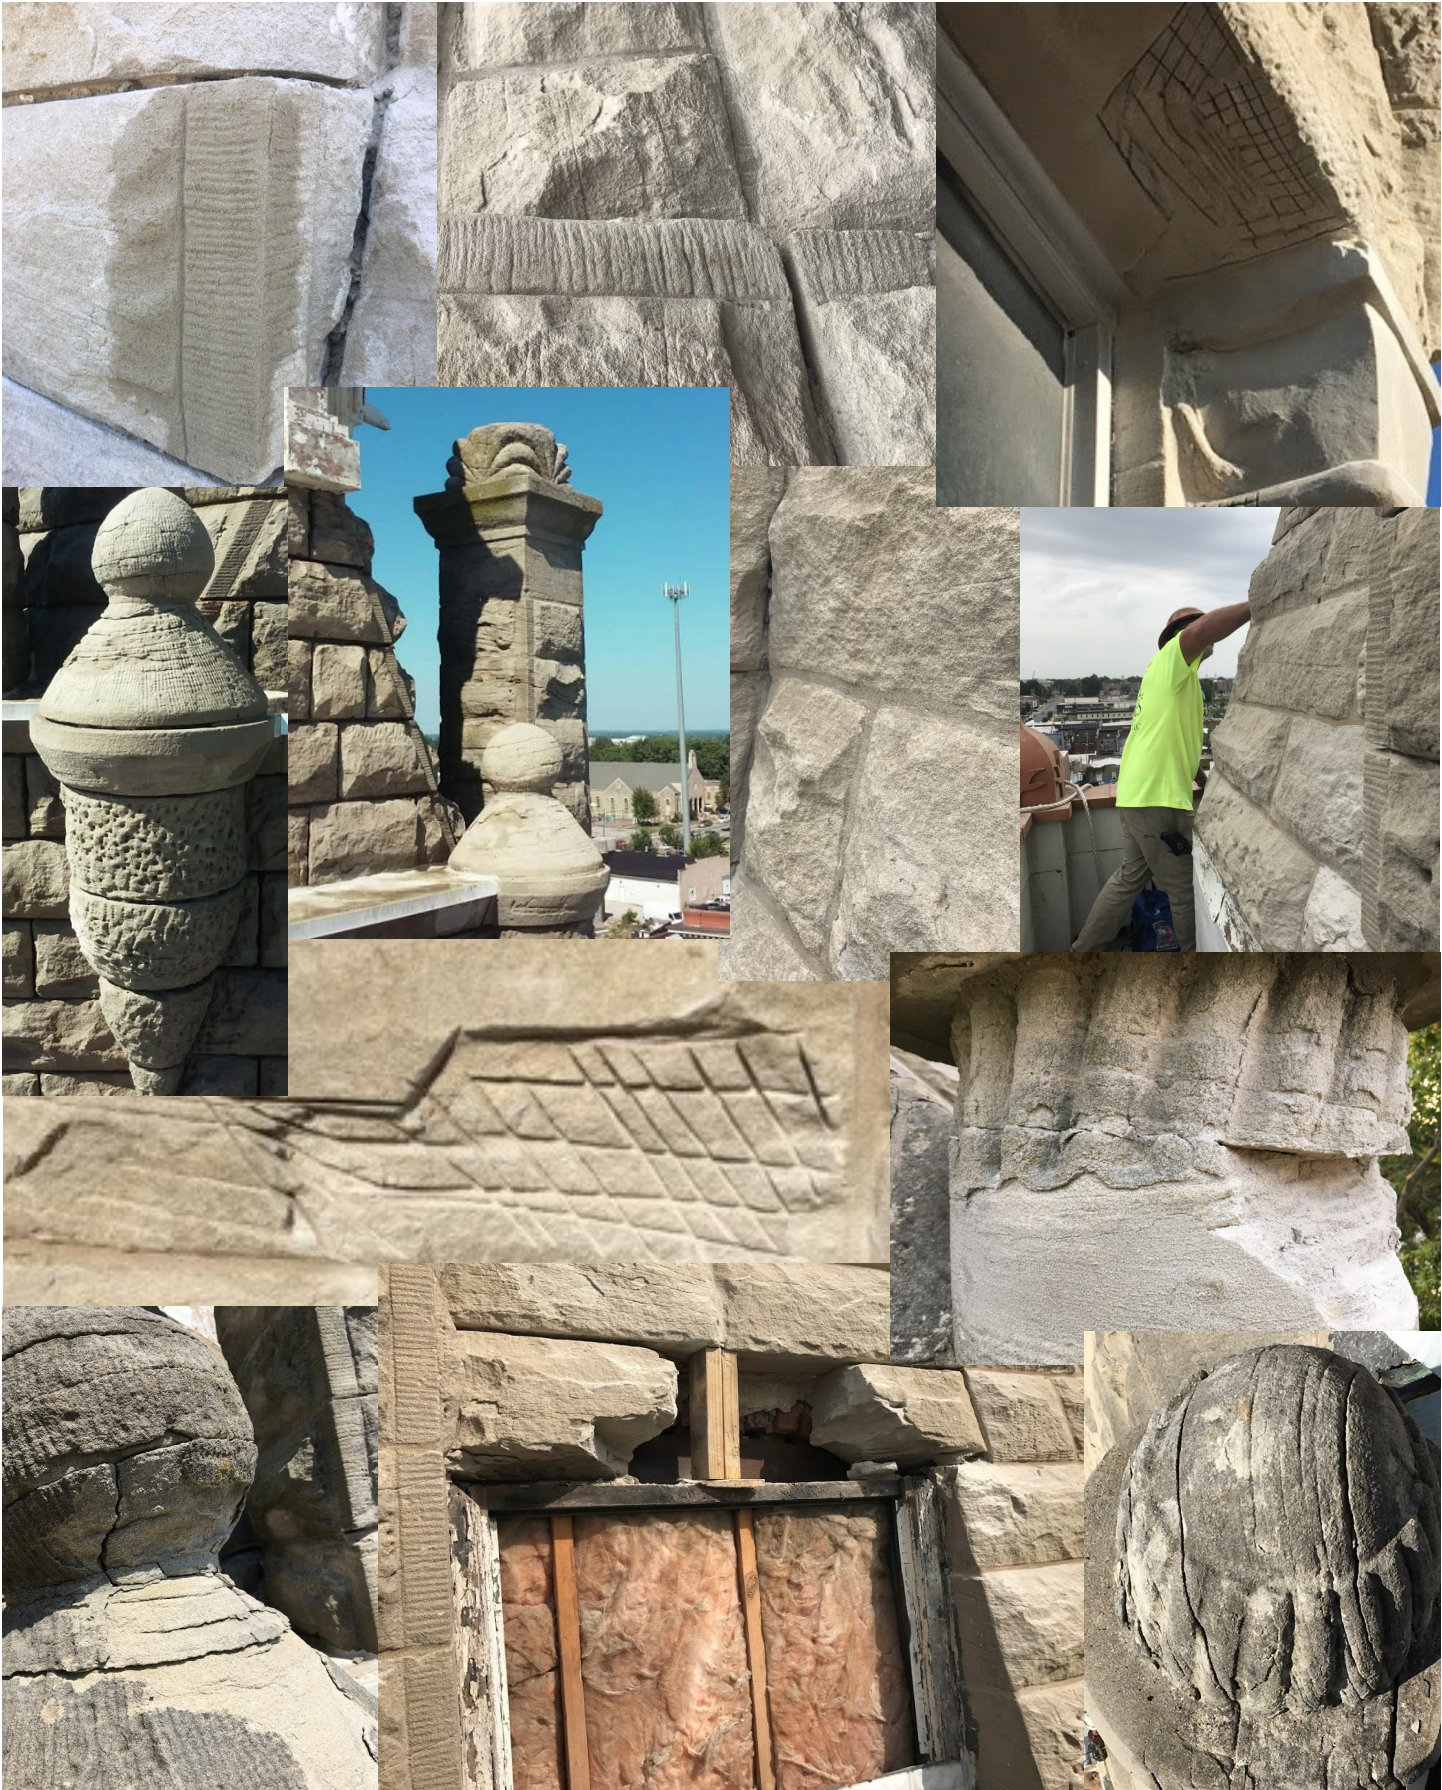
Stone: Cleaning, patching, tuck-pointing and 100% stone consolidation treatment.

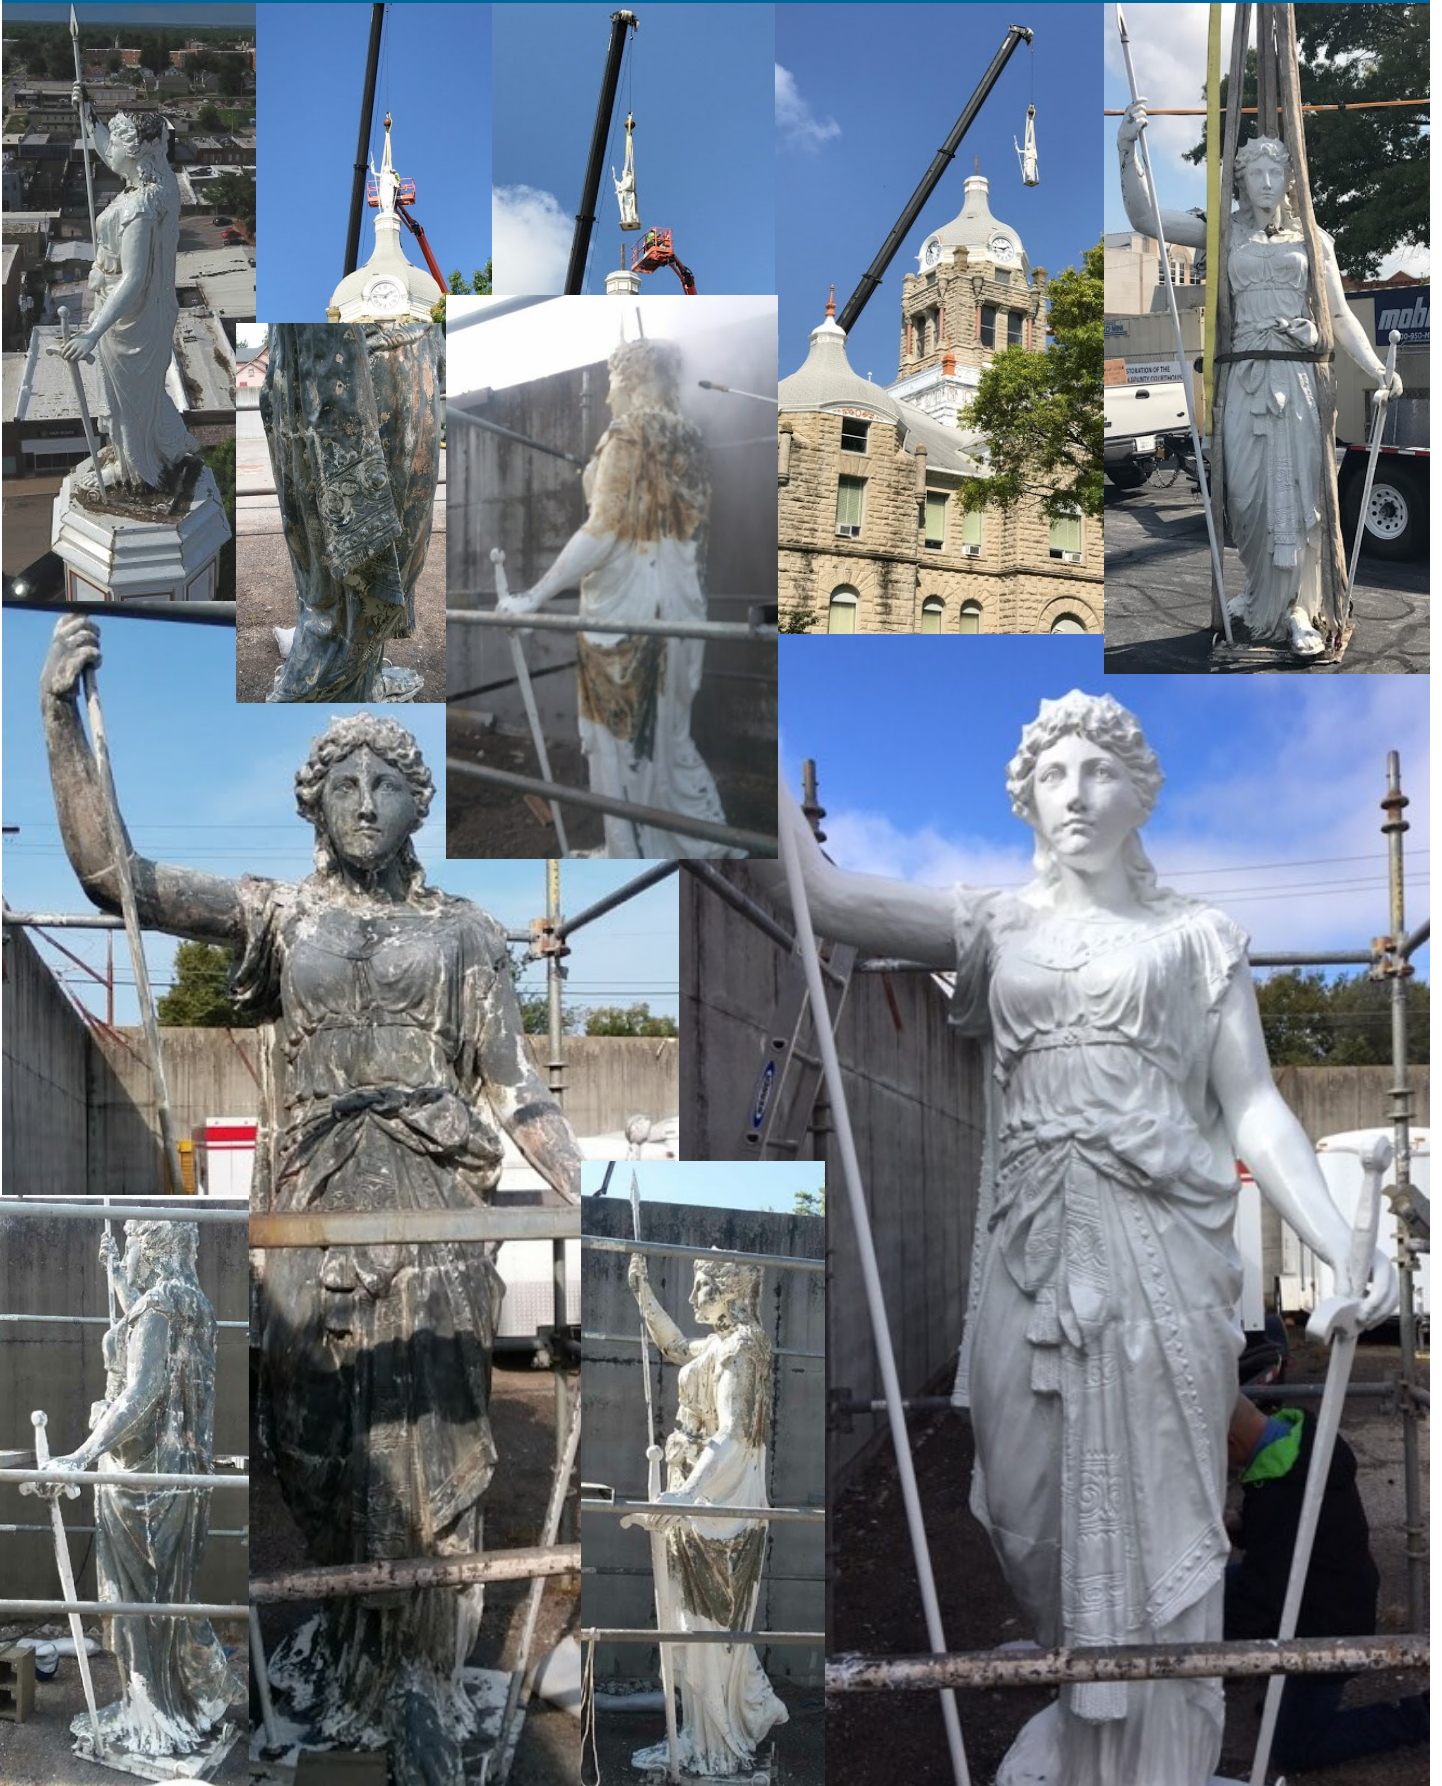
Minerva: Restoration completed (paint striped and re-painted); installation pending.

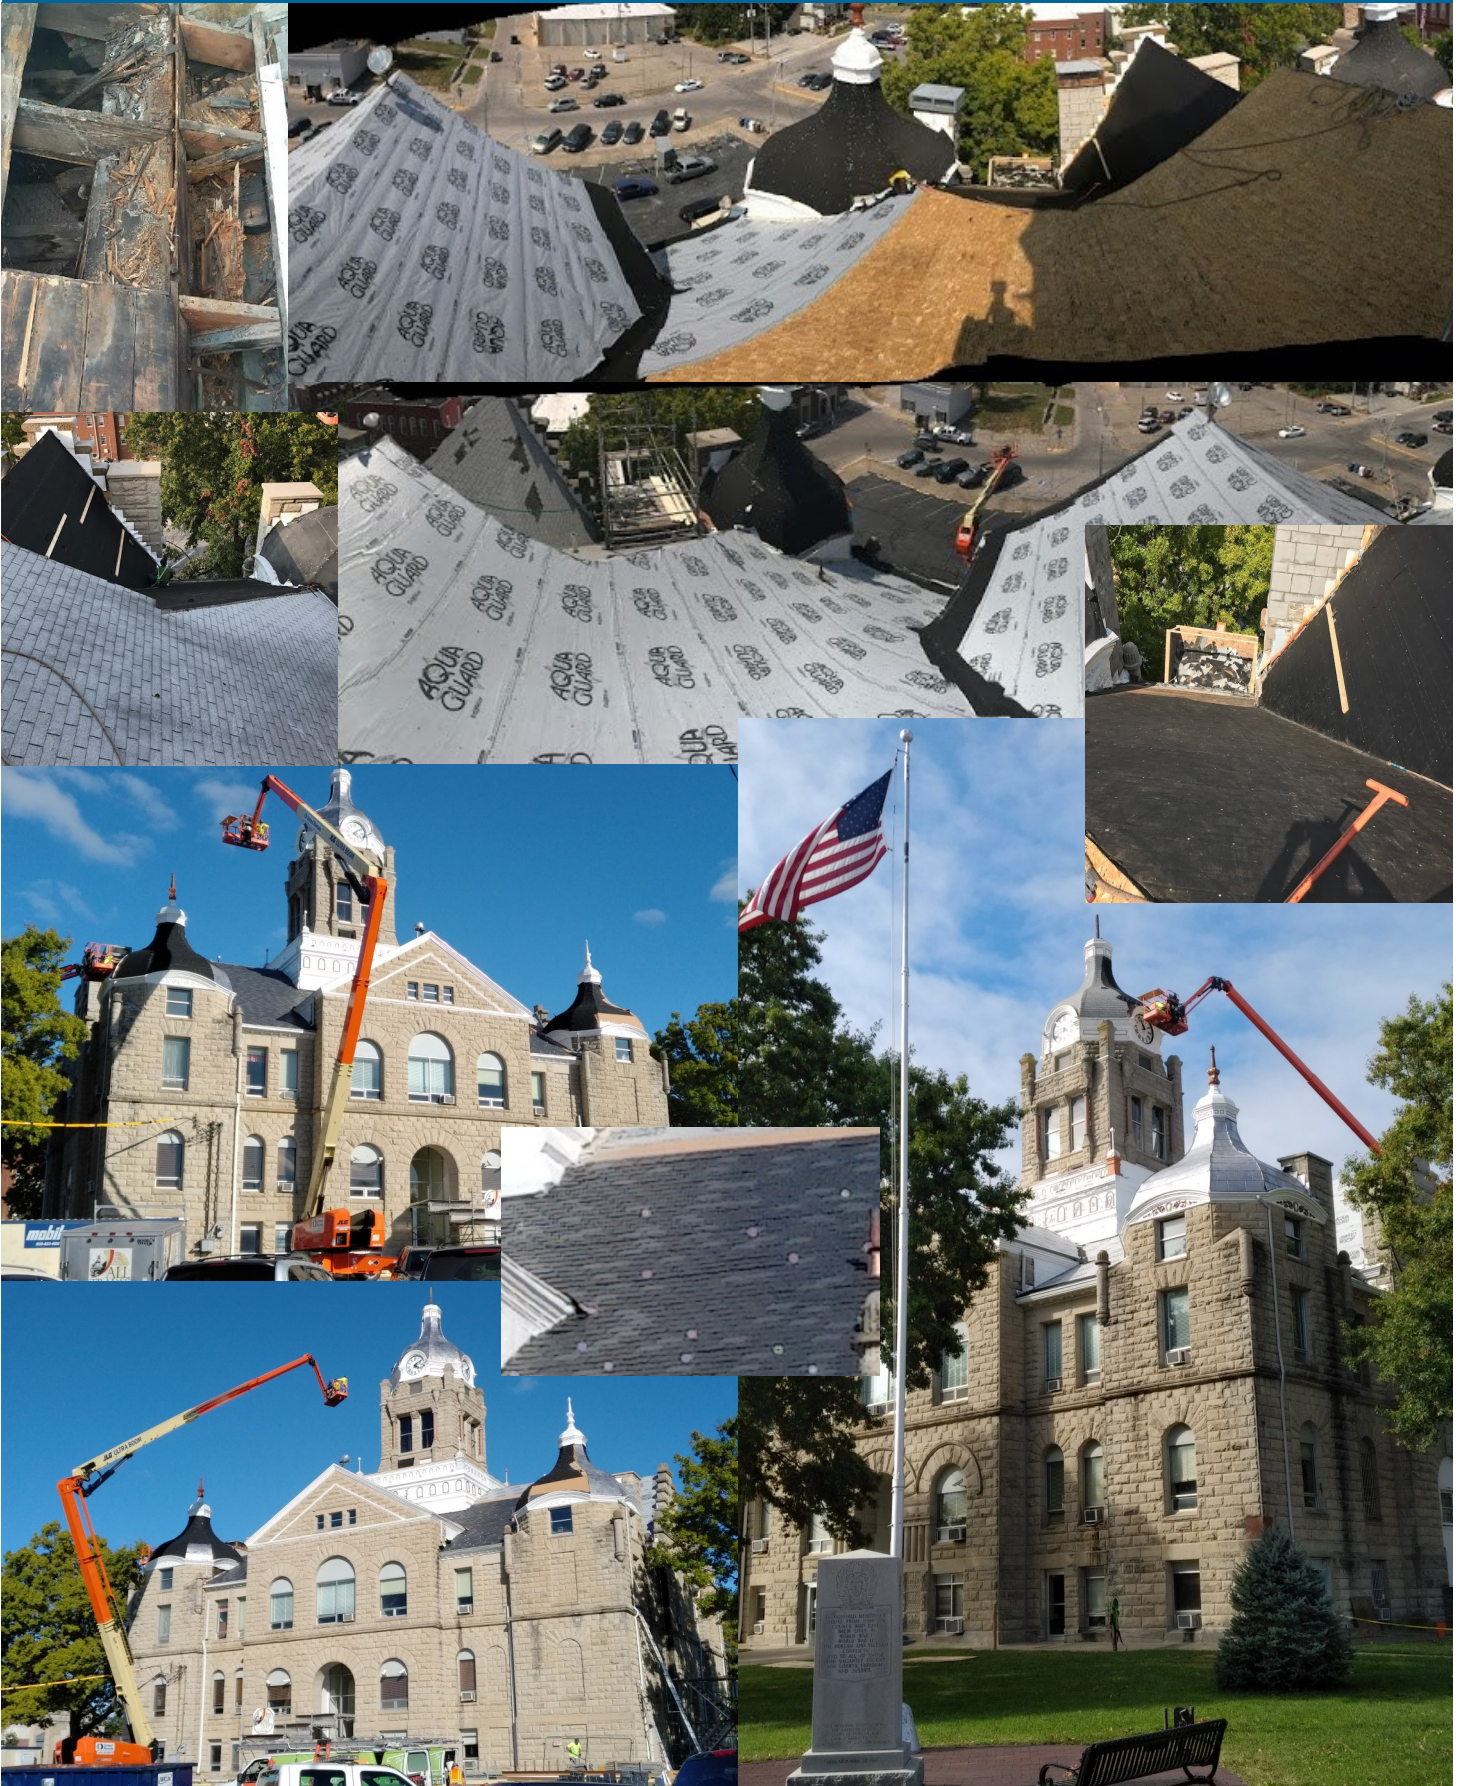
Roof: Shingles removed, papered in, Eco Star with ice dams partially installed.
