JOHNSON COUNTY COURTHOUSE ROOF AND TOWER REPAIRS

SHPO Milestone #2

October 2017

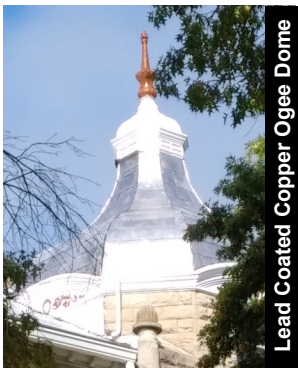
- South elevation; 100% Cleaned, 100% Tuck-pointed, and Patch repaired. Clock area has been primed and painted.
- Southwest Ogee Dome; Painted area has been prep-washed, scraped, primed and painted. Roof has been torn off and papered in.
- West elevation; 100% Cleaned, 100% Tuck-pointed, Clock area has been washed and scraped and is ready for priming.
- Northwest Ogee Dome; Painted area has been prep-washed, scraped and primed. Roof has been torn off and papered in.
- North elevation; 100% Cleaned, Tuck-pointed, and Patch Repaired. Clock area has been primed and painted.
- Northeast Ogee Dome; Painted area has been prep-washed. Roof has been torn off and papered in.
- East elevation; 100% Cleaned, Tuck-pointed, and Patch Repaired. Clock area has been primed and painted.
